Manhole Inspection Summary

Manhole # S21GG_058MH

Insp Date: **6/19/07 2:26 PM**

Location Address: **1428 MOUNT ST**

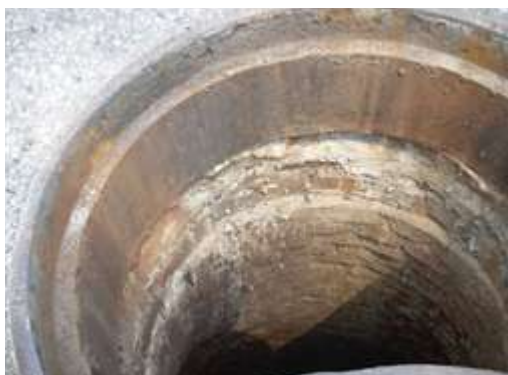
Defect 1

Condition: ☐ Sound ☐ Cracked ☐ Root Intrusion ☐ Loose Brick ☒ **Deteriorated**

DETERIORATION OF CHIMNEY

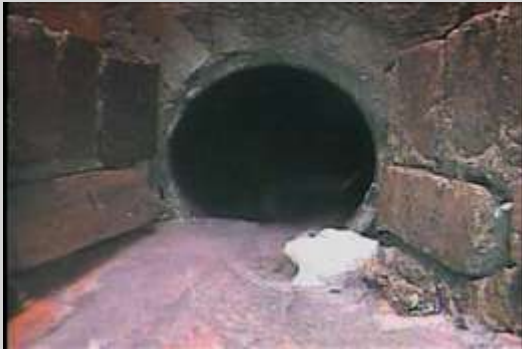
12 O'Clock Outflow

8 in. Circular Gravity Sewer
Pipe Out @ 12 O'Clock

Pipe Height: **8.4** (in.) Rod and Bar (Angled)
Pipe Material: **Clay** ☐ Pipe Lined
Invert Depth: **8.78** (ft.) Flow Characteristics: **Slow**
Deposits: ☒ None ☐ Mud ☐ Sludge ☐ **Debris** ☐ Grease
Silt Depth: (in.) Deposits Extent:
Infiltration: **None** Pipe Seal Cond: **Sound**

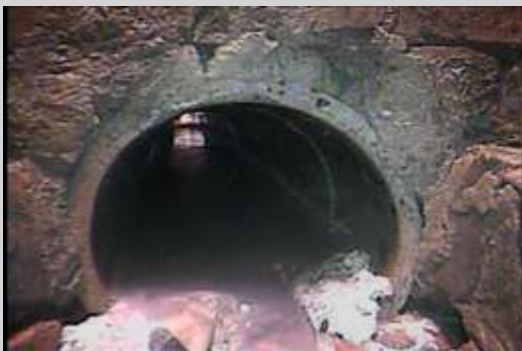
3 O'Clock Inflow

8 in. Circular Gravity Sewer
Pipe In @ 3 O'Clock

Pipe Height: **8.4** (in.) Rod and Bar (Angled)
Pipe Material: **Clay** ☐ Pipe Lined
Invert Depth: **8.15** (ft.) Flow Characteristics: **Slow**
Deposits: ☐ None ☐ Mud ☐ Sludge ☒ **Debris** ☐ Grease
Silt Depth: **4** (in.) Deposits Extent: **Medium**
Infiltration: **None** Pipe Seal Cond: **Sound**
